**ASTM E 90 SOUND TRANSMISSION LOSS  
TEST REPORT**

**THERMA-TRU DOORS**

**SERIES/MODEL: Classic-Craft, Fiber-Classic, and Smooth-Star**

**TYPE: 3/6-8 Insulated IG Full Lite Side Hinged Door**

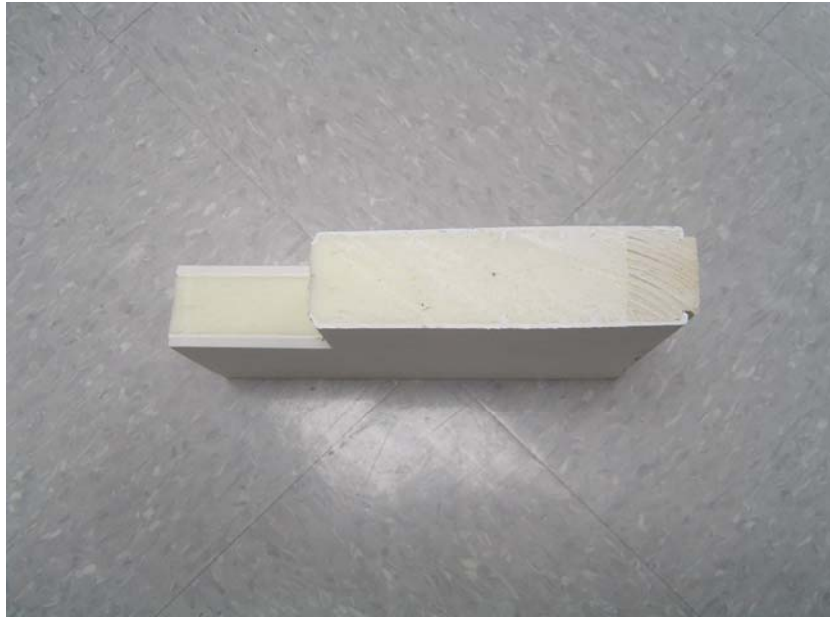
**Leaf Cross Section at Hinge Stile**

**Comments:** The lock stile was constructed from 3-5/8" by 1-1/2" plywood. The hinge stile was constructed from 7/8" by 1/2" wood. The top rail contained a composite member measuring 1" by 1-1/2". The bottom rail contained a composite member measuring 7/8" by 1-1/2". The door knob and deadbolt holes were reinforced by the lock stile. The hinge stile and lock stile were capped with 5/16" by 1-5/16" wood.

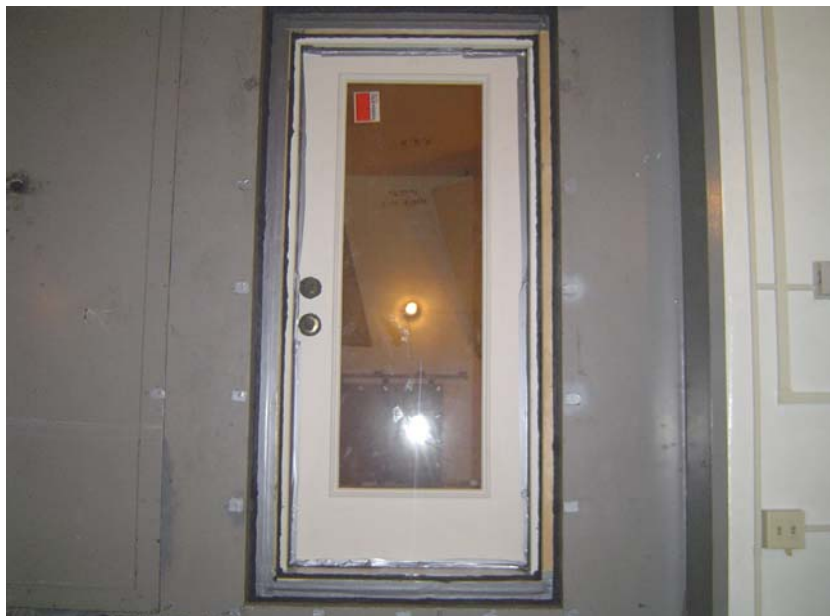
**Source Room View of Installed Inoperable Specimen**

\* For test number 74367.01A, the following deviation from the standard was performed: The door was tested in a sealed condition and was not operable during the test. The door leaf was sealed on both sides with duct tape.
