**ASTM E 90 SOUND TRANSMISSION LOSS
TEST REPORT**

THERMA-TRU DOORS

SERIES/MODEL: Slimline

TYPE: 6/8 Sliding Patio Door

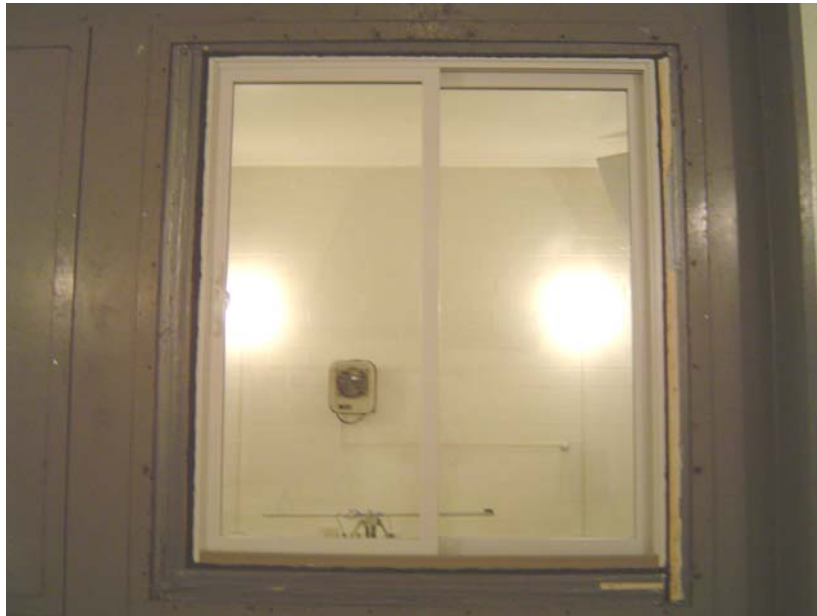
Receive Room View of Installed Specimen

The 80" by 86" plug was removed from the filler wall assembly. A 2" x 8" wood frame was used to reduce the test opening size to 71-3/4" by 80". The 6/8 sliding patio door was placed on a foam isolation pad in the test opening. Duct seal was used to seal the perimeter of the test specimen to the test opening on both sides. The interior side of the 6/8 sliding patio door frame, when installed, was approximately 1/4" from being flush with the receiving room side of the filler wall. A stethoscope was used to check for any abnormal air leaks around the test specimen prior to testing. For the operable test, the door panel was opened and closed at least five times prior to testing.

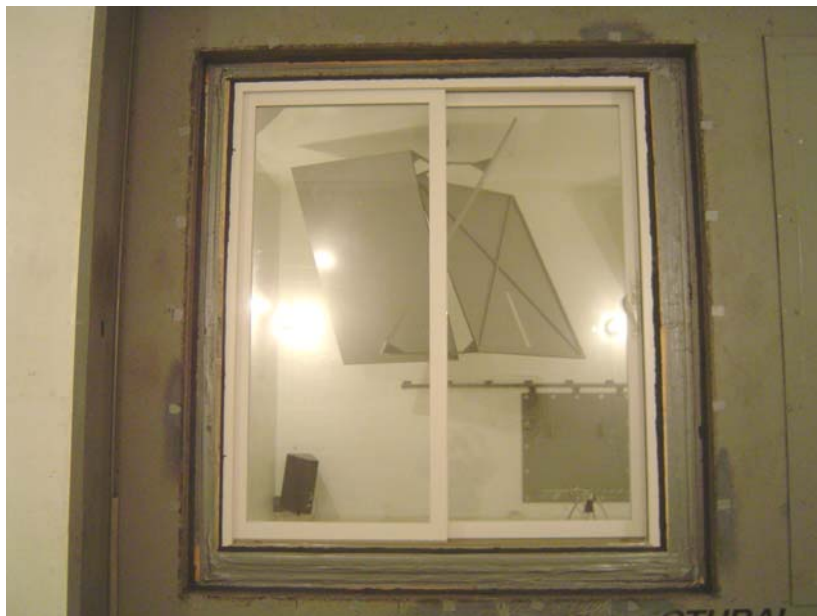
Source Room View of Installed Specimen
